CONNECTICUT RIVER BASIN
ASHFIELD, MASSACHUSETTS

ASHFIELD POND DAM
MA 00523

PHASE 1 INSPECTION REPORT
NATIONAL DAM INSPECTION PROGRAM

AUGUST 1978

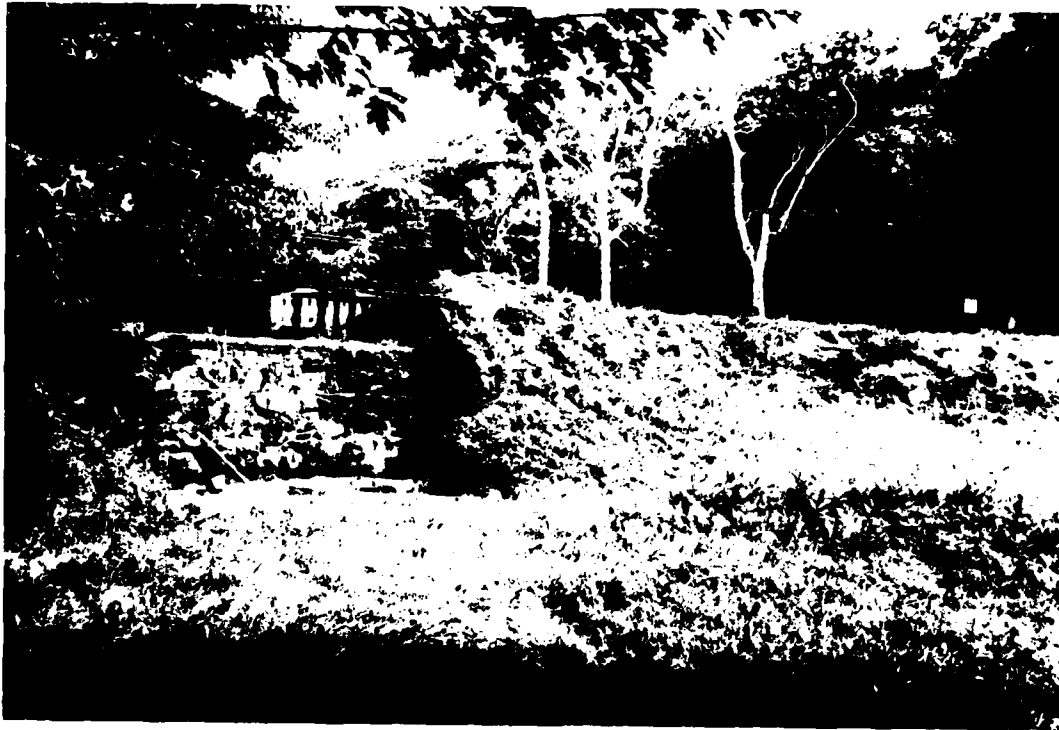
2. VIEW OF SPILLWAY AND DOWNSTREAM SLOPE IN VICINITY OF EAST ABUTMENT.

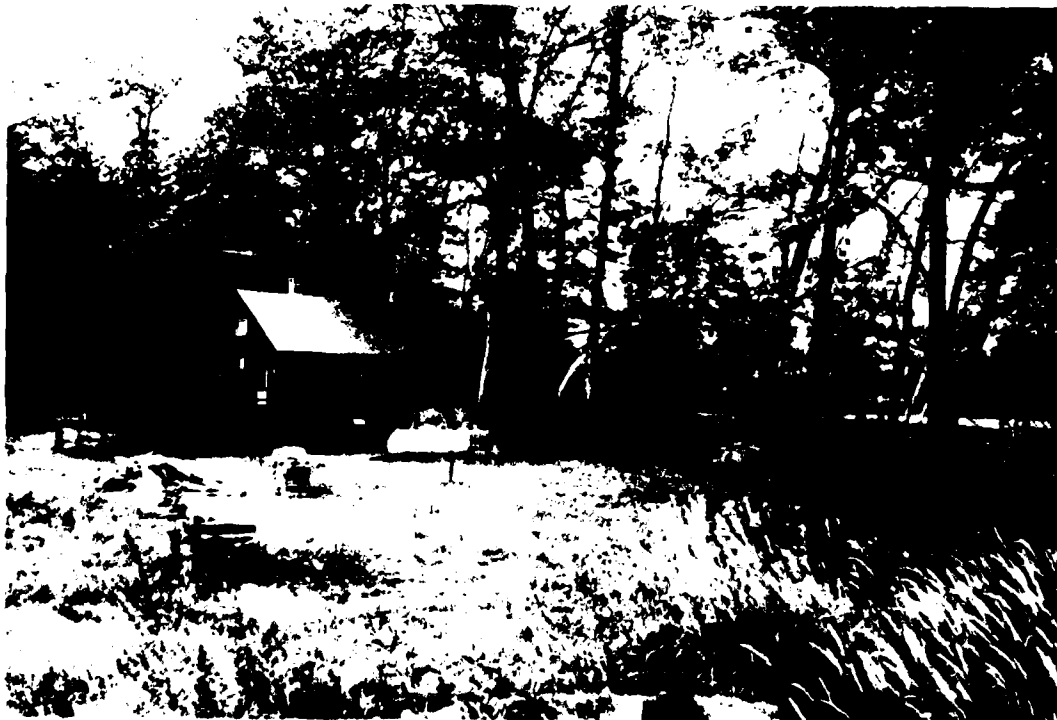
3. VIEW OF DOWNSTREAM SLOPE IN VICINITY OF WEST ABUTMENT. NOTE TREES ON SLOPES AND CLOSE PROXIMITY TO DAM OF RESIDENCE.

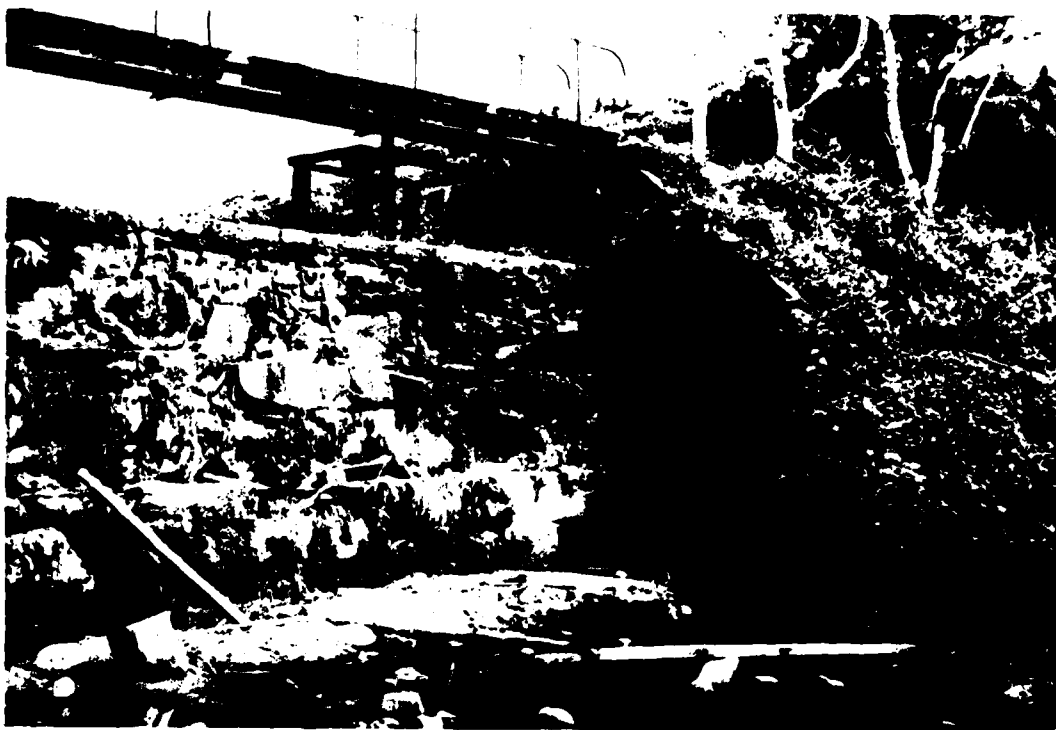
The stone masonry spillway appears to be in good condition with only few stones missing. Mortar pointing is missing over large areas and there is some vegetation growing from the joints. The concrete on the spillway sill is in generally good condition, however, the crest has been sedimented with beach sand and there is some vegetation growing. There are no flashboards in use, and it is reported they have never been used. The stone masonry, the concrete base of the training walls and the spillway

channel floor are in good condition. The wood deck of the pedestrian bridge is in fair condition with only a few boards broken and/or missing. The steel support beams are in good condition, however, they are rusty. (See Photograph No. 6).

6. CLOSEUP VIEW OF SPILLWAY, LOW LEVEL OUTLET AND OPERATING STAND FOR SLUICEGATE. NOTE VEGETATION, CAVITIES AND DEBRIS.

3. Missing stones should be replaced on the downstream face of spillway.
4. Crest of spillway should be cleaned and vegetation removed.
5. Low level outlet gate mechanism should be made operable, greased and painted. The gate shaft should be cleaned and provisions made for preventing a reoccurrence of the silting of the shaft. Consideration should be given to construction of a gate house.

6. The missing and broken wood decking for the pedestrian bridge should be replaced and the steel beams should be painted.
7. The highway drainage channel located along the downstream toe of the embankment should be rerouted. Areas along the toe which have been eroded should be refilled with suitable material.
